Re: October 2017 Monthly Progress Report
Administrative Settlement Agreement and Order on Consent for Removal Action
USEPA Region 10 Docket No. CERCLA 10-2009-0255
Gasco Sediments Site within the Portland Harbor Superfund Site

Attachment A Monthly Visual Monitoring Report for Pilot Cap Vicinity

Visual Observations Log Form

Project: NW Natural – Gasco

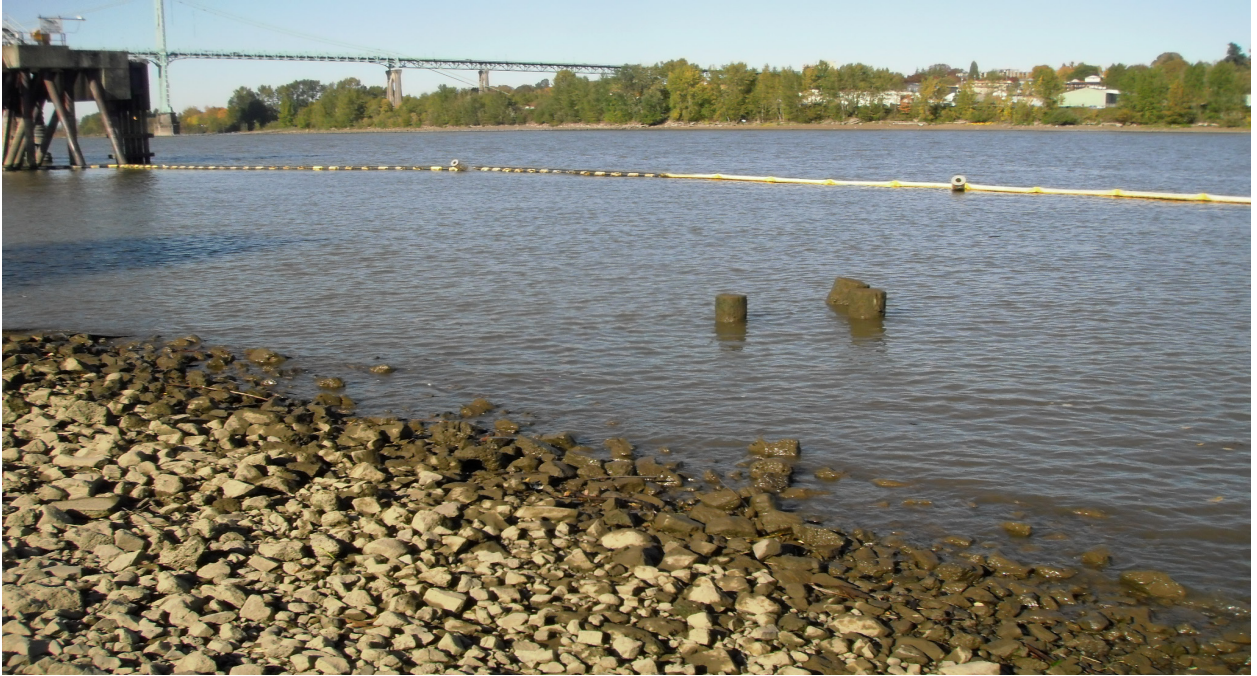
Photo 1

During the observation, the FAMM containment boom was placed across the cap area from the ship dock to the upriver dolphin. Two buoys that identify the cap area to mariners are in place as installed, but the buoys are not in an upright position due to extremely low water levels. The positions of the FAMM oil boom and warning buoys are shown in Photo 1.

FAMM Oil Boom Placement and Mariner Warning Buoys at Pilot Cap Area (10/26/2017)

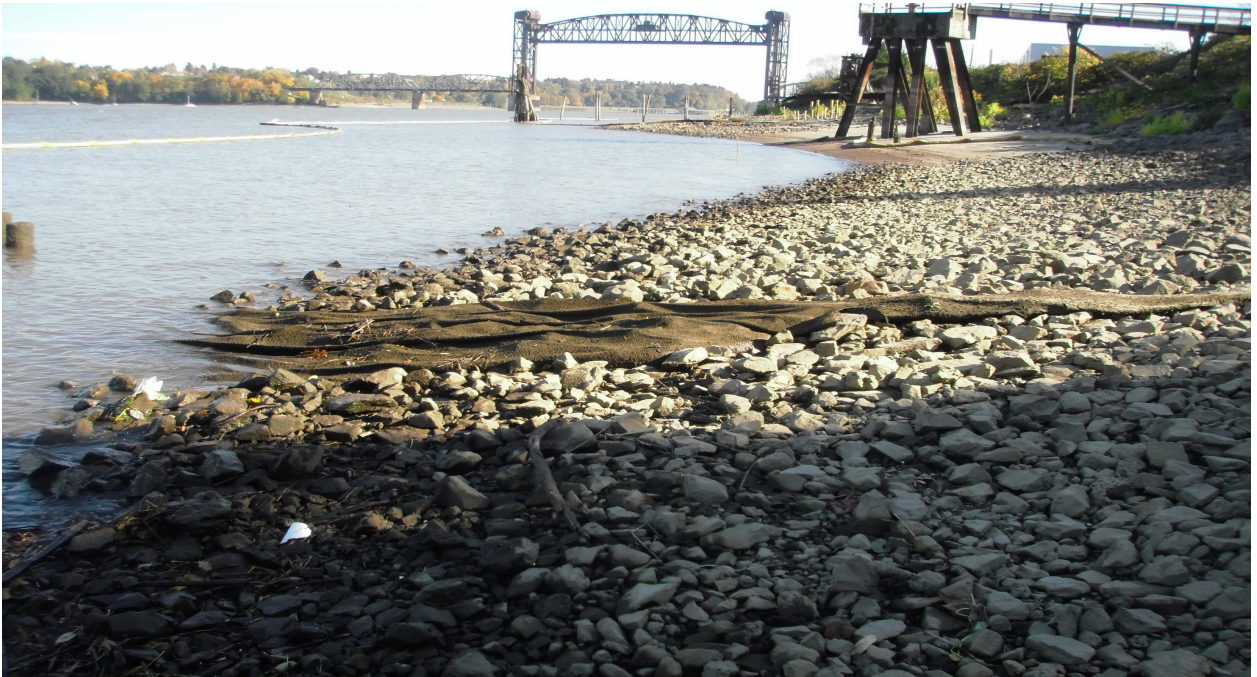
Photo 2

Exposed organo-clay mat material segments were observed at the current river levels. A segment 5 feet in length is exposed approximately 10 feet landward of the water's edge, near the lateral mid-point of the cap area. A 15-foot section is exposed shoreward of the water's edge, perpendicular to the shoreline at the upriver boundary of the cap area as seen in Photo 2. A section of organo-clay mat material measuring 40 feet in length is exposed near the downriver extent of the cap at the water's edge.

Mat material visible at the upriver extent of the cap area (10/26/2017)

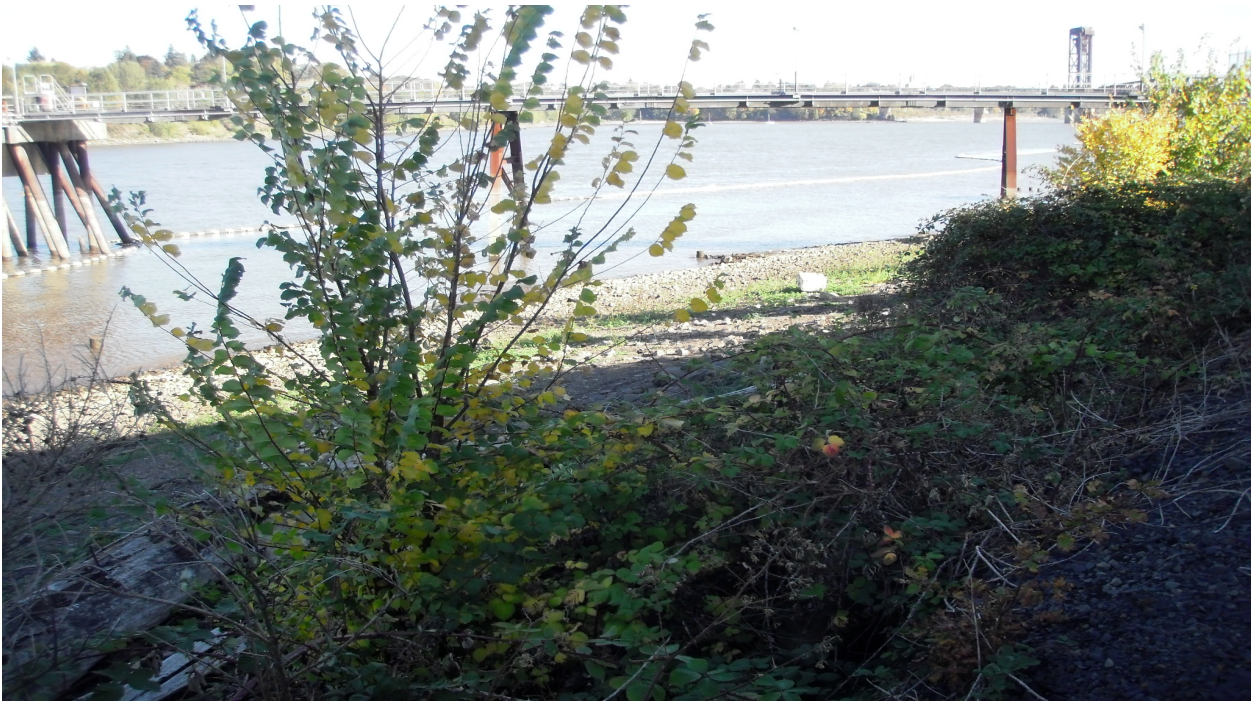
No sheen is evident in or around the cap area. Photo 3 shows the water surface and shoreline immediately downriver of the sediment cap.

Photo 3
Conditions Immediately Downriver of Cap Area (10/26/17)
